Manhole Inspection Summary

Manhole # S41Y__007MH

Insp Date: **12/1/08 10:35 AM**

Location Address: **side of 1001 E McComas st**

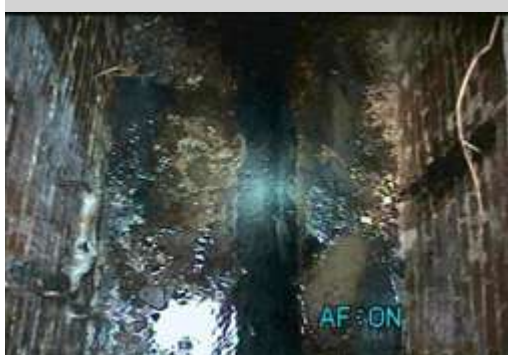
Defect 3

Surcharge ☒ **Evidence Of Surcharge** Depth: **4** (ft.) ☐ Active Surcharge Present

evidence of surcharge

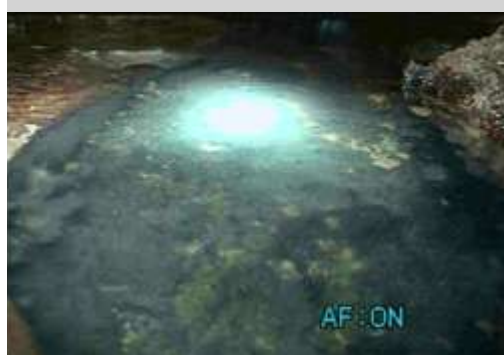
Defect 4

Condition: ☐ Sound ☐ Cracked ☐ Root Intrusion ☐ Deteriorated ☐ Leaks ☒ **Debris**

channel debris

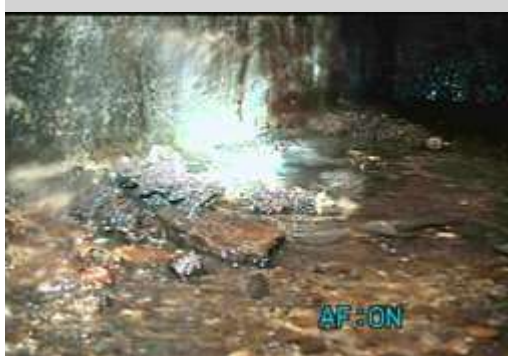
Defect 5

Condition: ☐ Sound ☐ Cracked ☐ Root Intrusion ☒ **Deteriorated** ☐ Leaks ☐ Debris

Deteriorating bench w/ debris

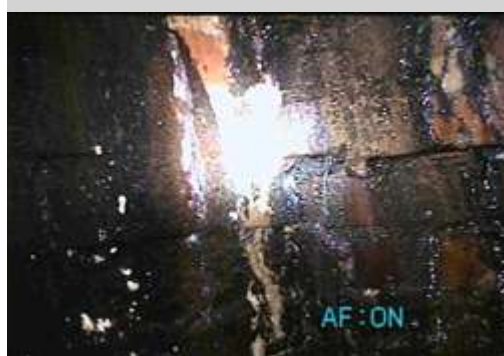
Defect 2

Condition: ☐ Sound ☐ Cracked ☐ Root Intrusion ☒ **Loose Brick** ☒ **Deteriorated**

Infiltration: ☐ None ☐ Joint ☒ **Cracks** ☐ Mortar ☐ Roots ☒ **Wall**

infiltration with water squirting out of barrel, loose bricks

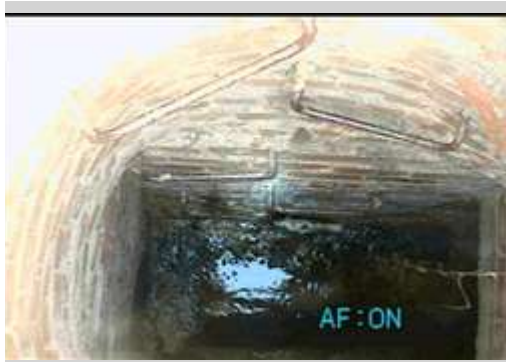
Defect 1

Steps Count: **7** Missing: **0** ☒ **Corroded**

cor. steps

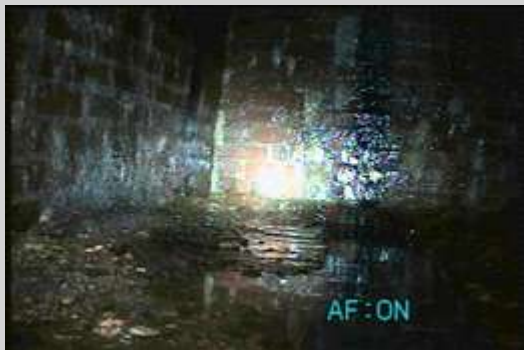
12 O'Clock Outflow

Cant get better pic, pipe is under ledge & in far left corner

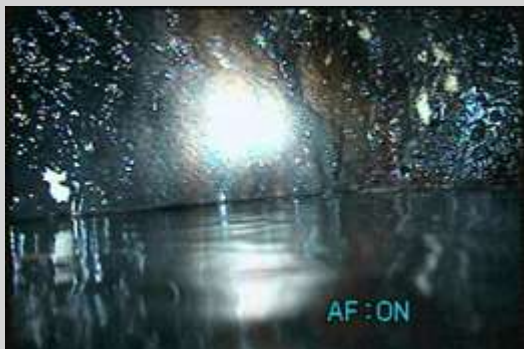
5 O'Clock Inflow

pipe is under water
